Eagle House
25 Memorial Drive
Lunenburg, MA 01462

Property Condition Assessment

February 23, 2018

VERTEX Project No: 48237

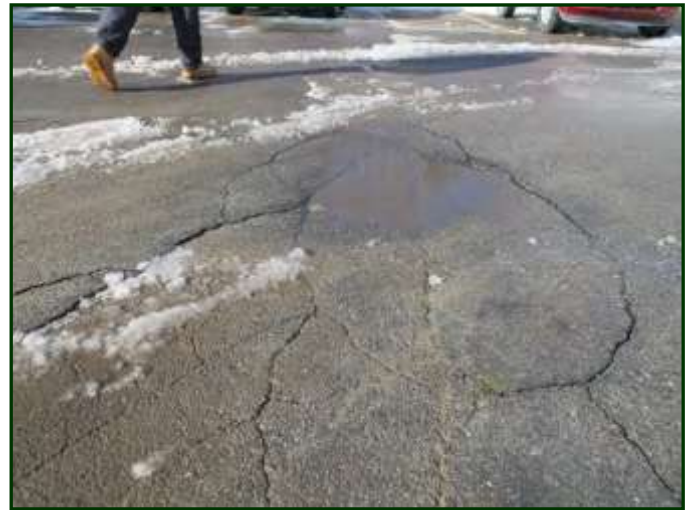
Photo #22: View of asphalt paving with cracking

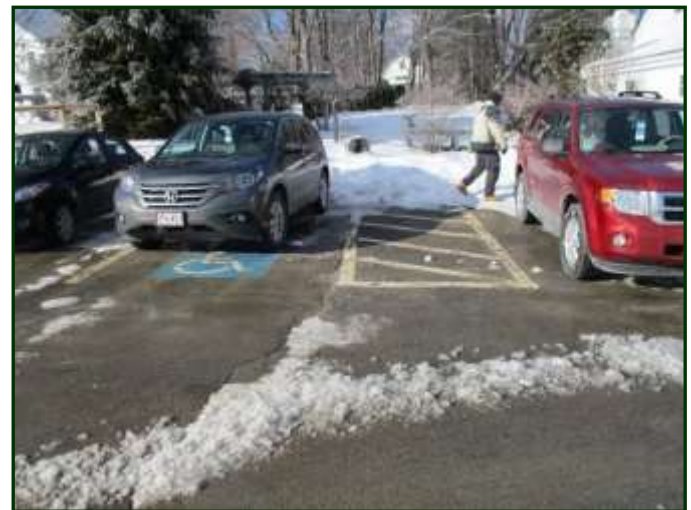
Photo #24: Accessible parking spaces adjacent to main building entrance. Note lack of vertical signage

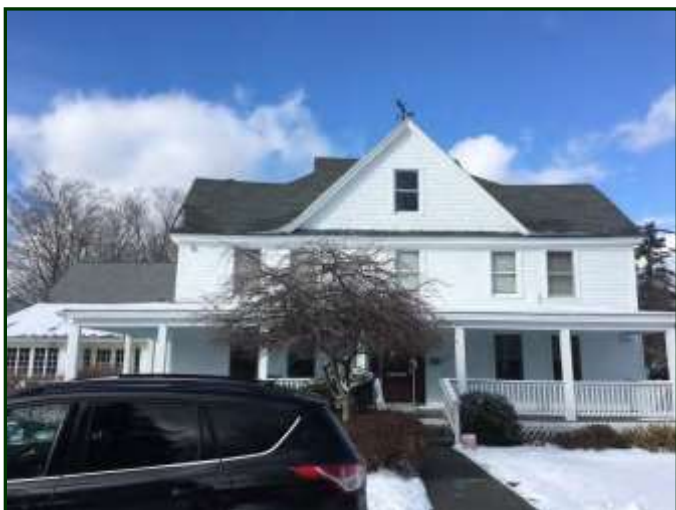
Photo #51: The south façade of the original building.

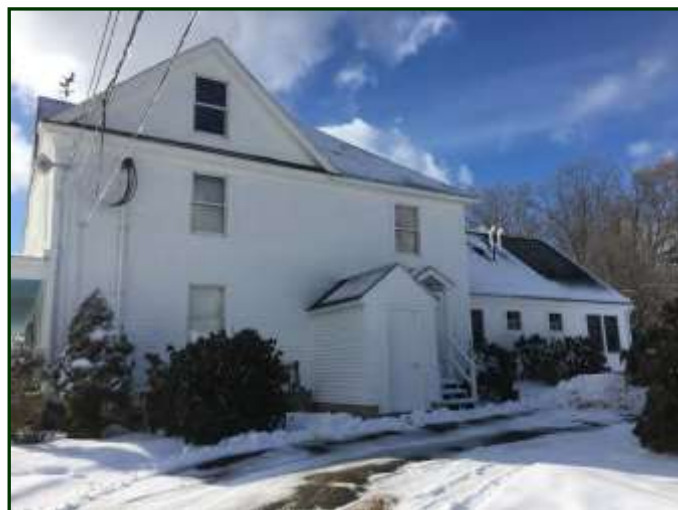
Photo #52: The east side of the original structure.

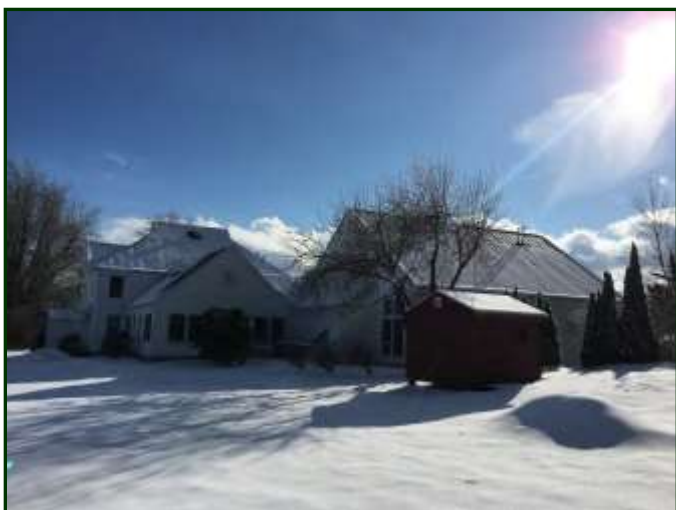
Photo #53: The east façades of the original house and the 1998 addition.

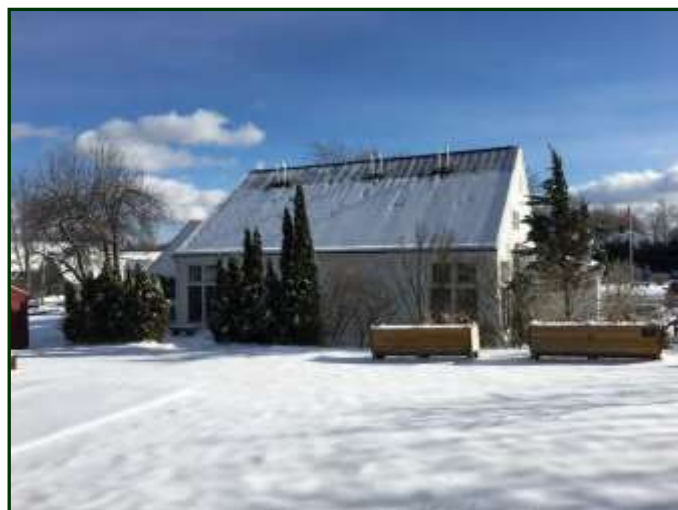
Photo #54: The north side of the addition.

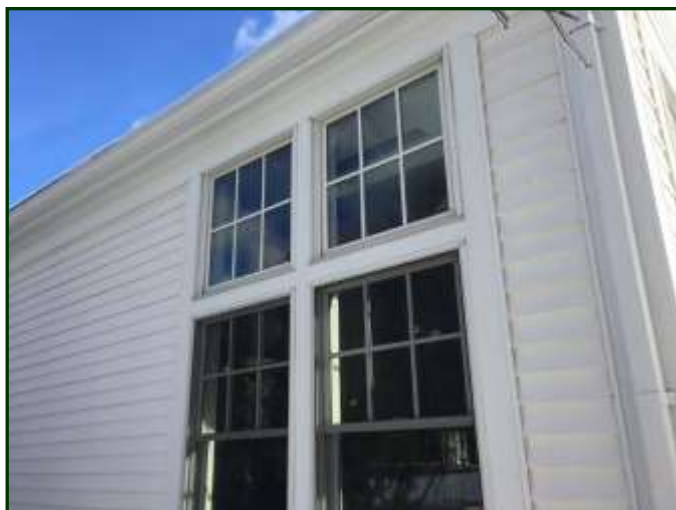
Photo #57: A double height window at the addition.

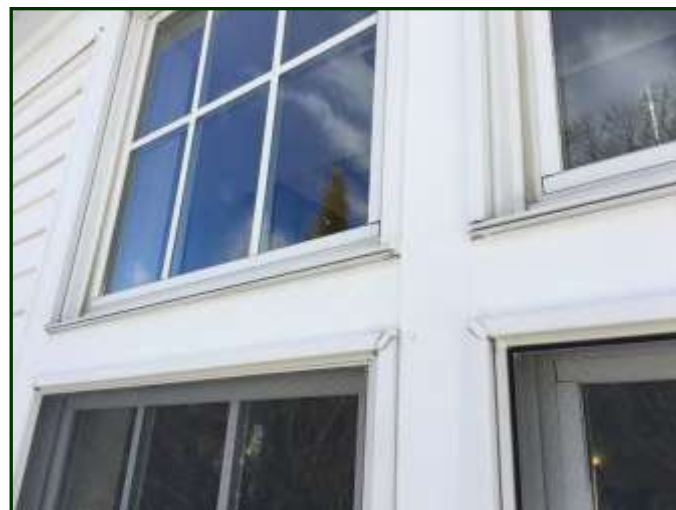
Photo #58: A detail of the transom of the window shown in Photo 9.

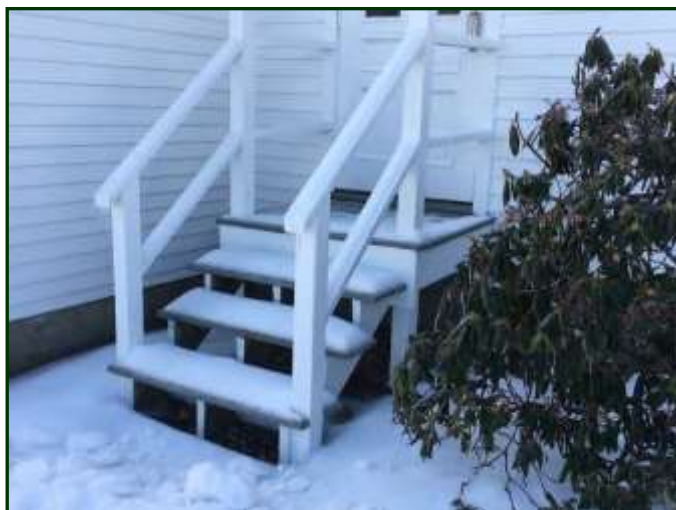
Photo #63: The rear stairs at the east side of the original building.

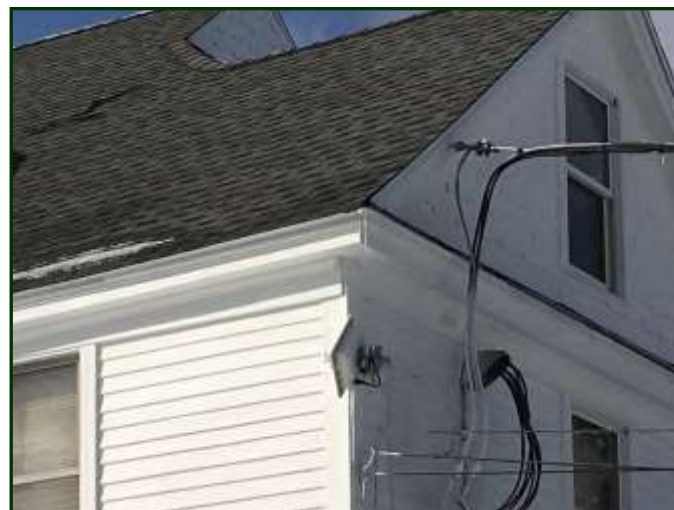
Photo #64: The southeast corner of the original building where the electrical service is attached.

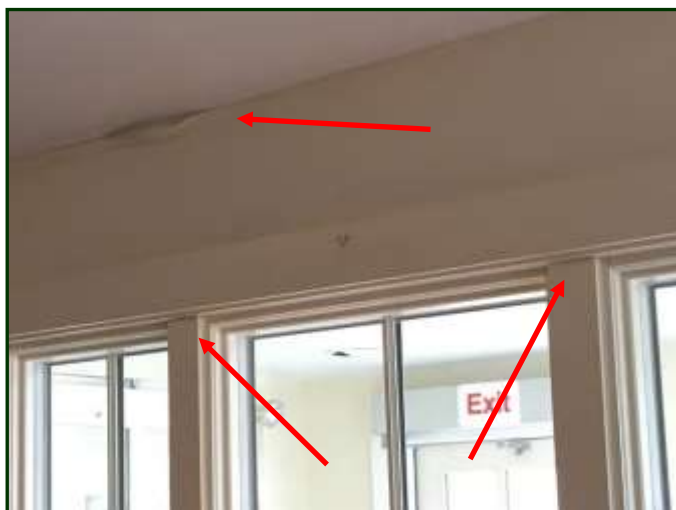
Photo #65: Evidence of potential water infiltration at the ceiling-wall intersection and deteriorated sealant at the window trim heads.

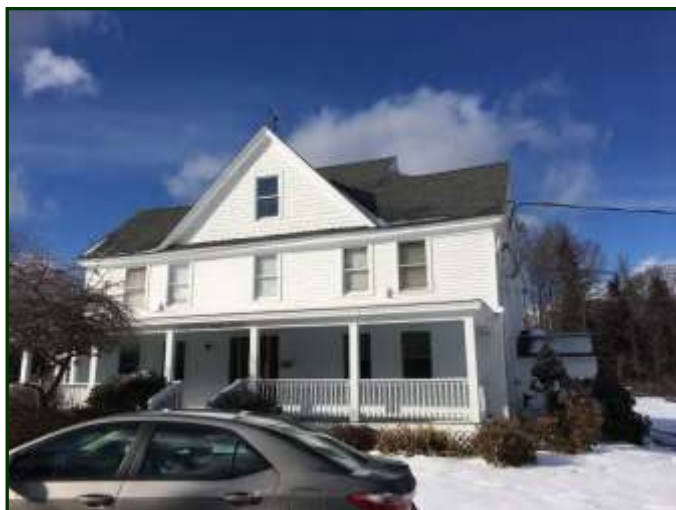
Photo #69: The southeast corner of the original structure roof.

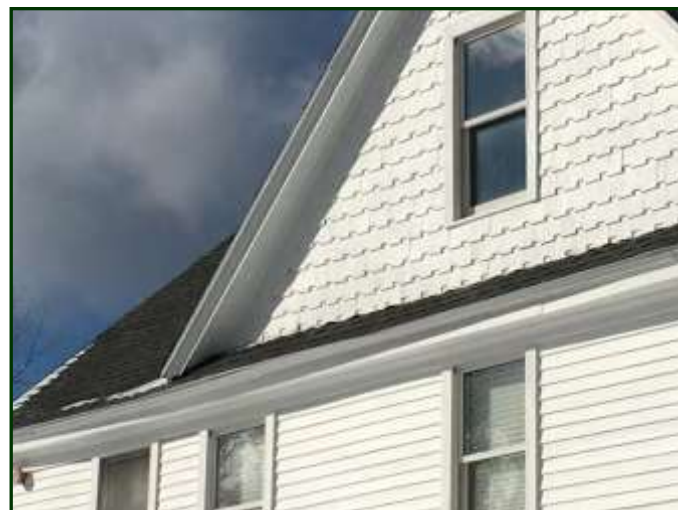
Photo #70: Detail of the gable dormer at the south façade.

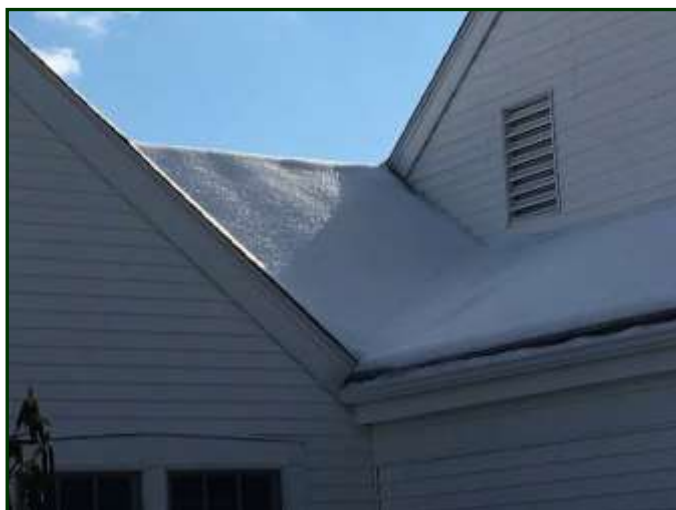
Photo #71: Valley at the northeast corner of the roof.

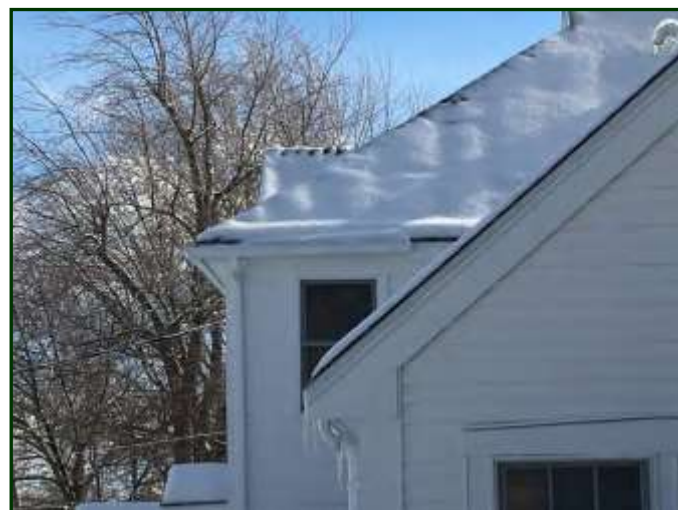
Photo #72: Detail of the east side of the original structure roof.

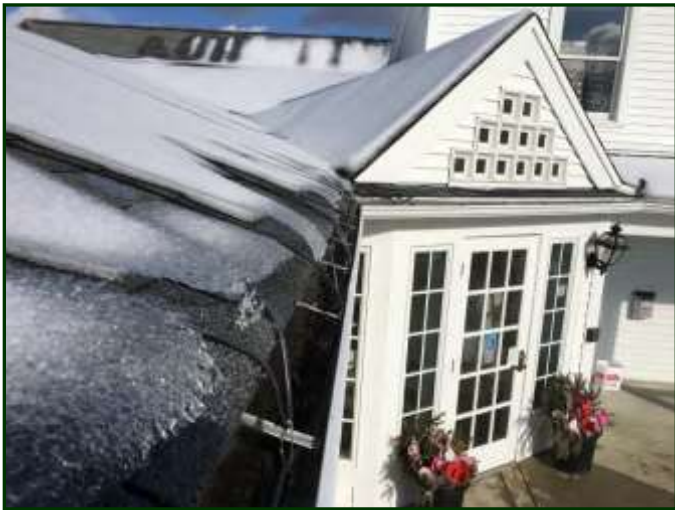
Photo #75: Eave with electric cabling for ice-snow melting

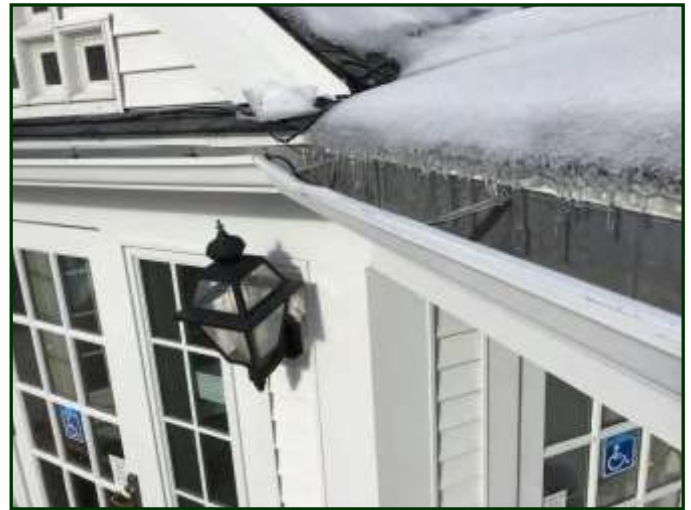
Photo #76: Detail of the fascia adjacent to front entrance door. Note the damaged fascia at center.

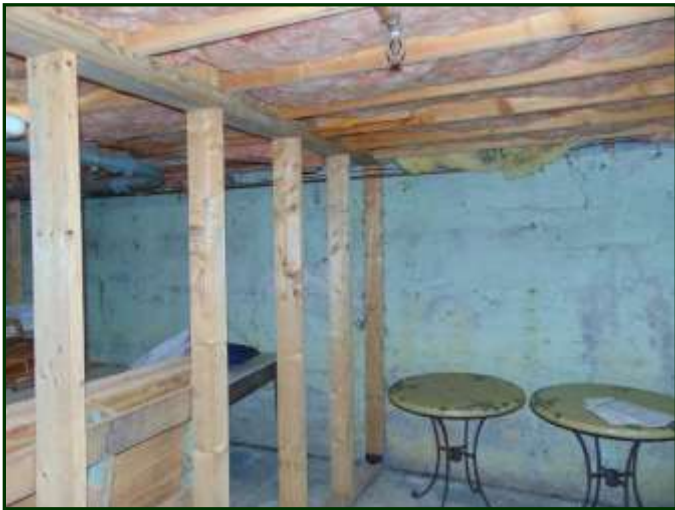
Photo #79: View of the concrete foundation walls below the original section of Eagle House.

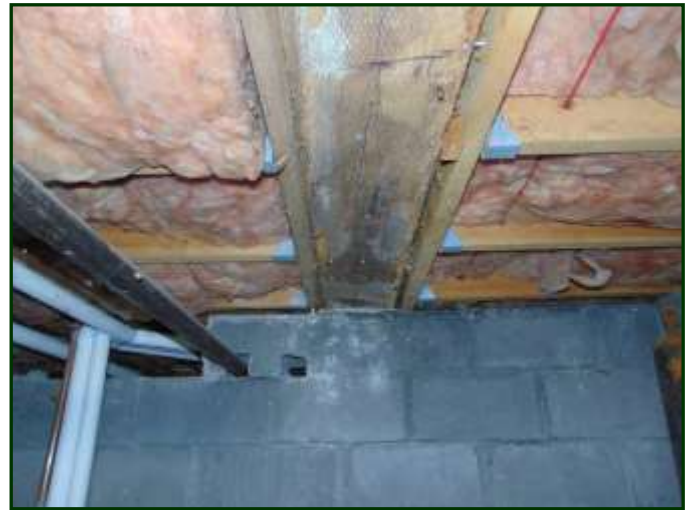
Photo #80: View of a wood beam supporting the first floor of Eagle House.

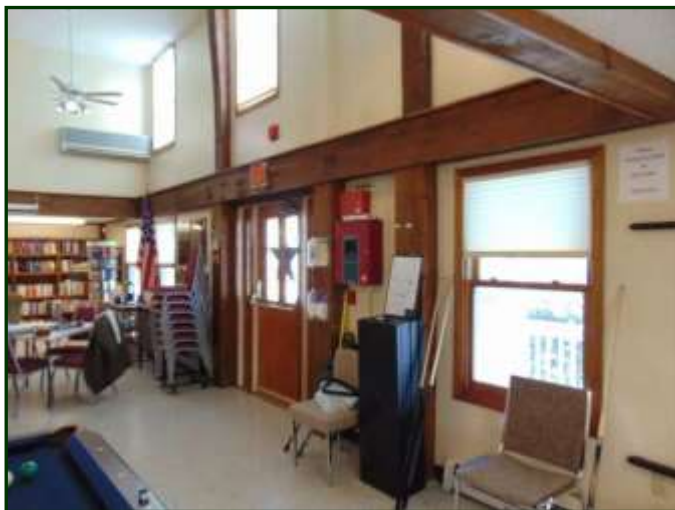
Photo #81: View of the exposed wood framing on the first floor of Eagle House.

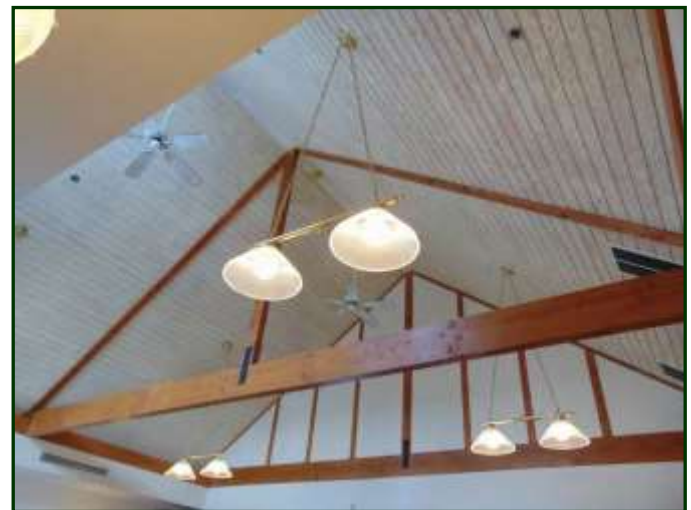
Photo #82: View of exposed wood roof framing at Eagle House.

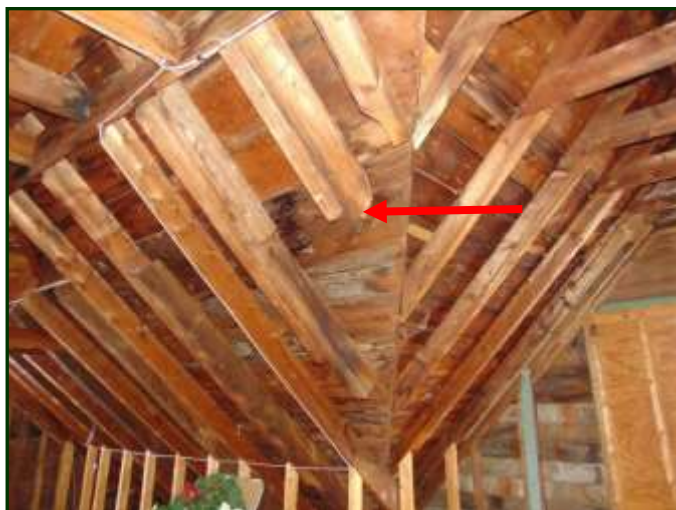
Photo #85: View of a valley on the south roof slope of the original Eagle House. Note the rafters were cut short.

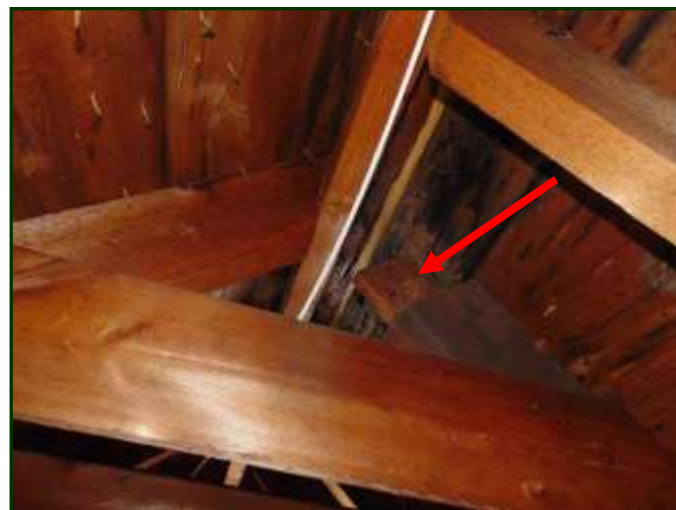
Photo #86: View of a rafter disconnected from the ridge board.

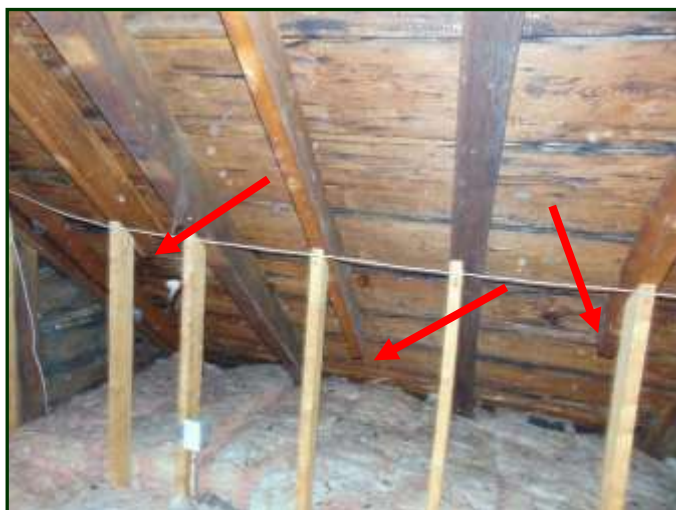
Photo #87: View of rafters that do not extend to the roof eave.

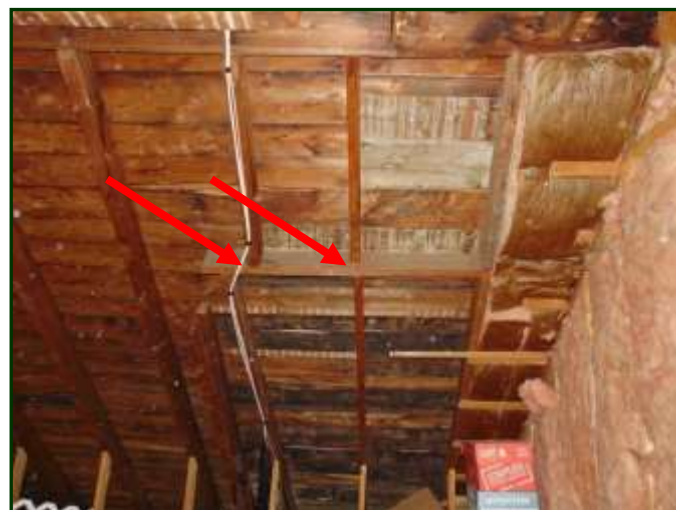
Photo #88: View of discontinuous roof rafters.

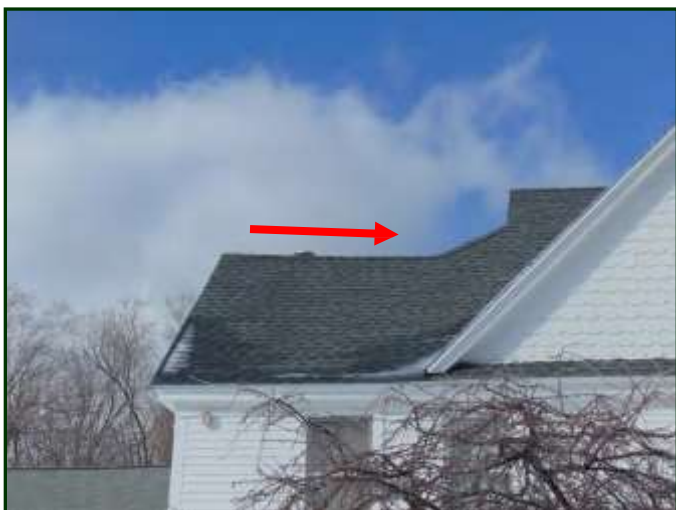
Photo #89: View of the south roof slope of Eagle House.
Note the slope along the ridge.

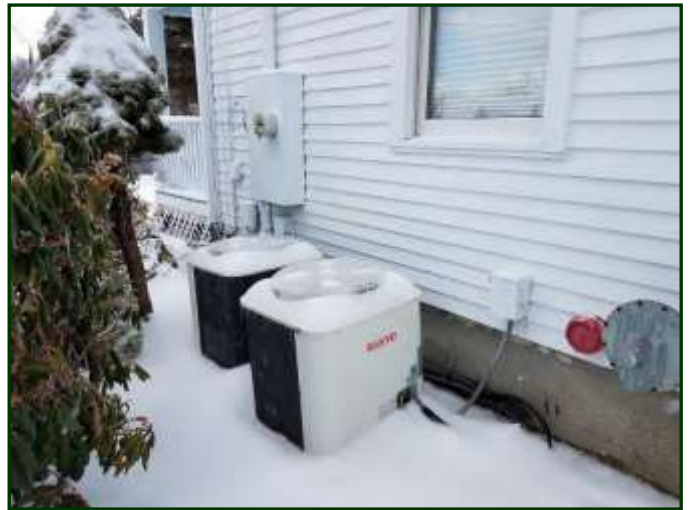
Photo #91: Condensing units—Sanyo

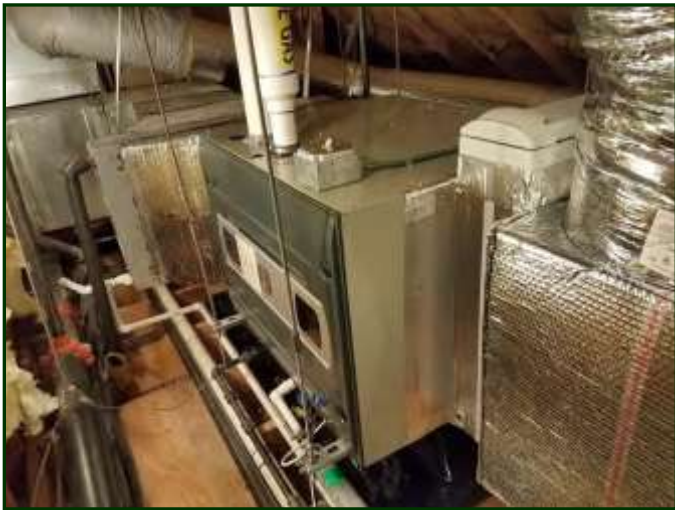
Photo #92: American Standard/Trane AHU in attic

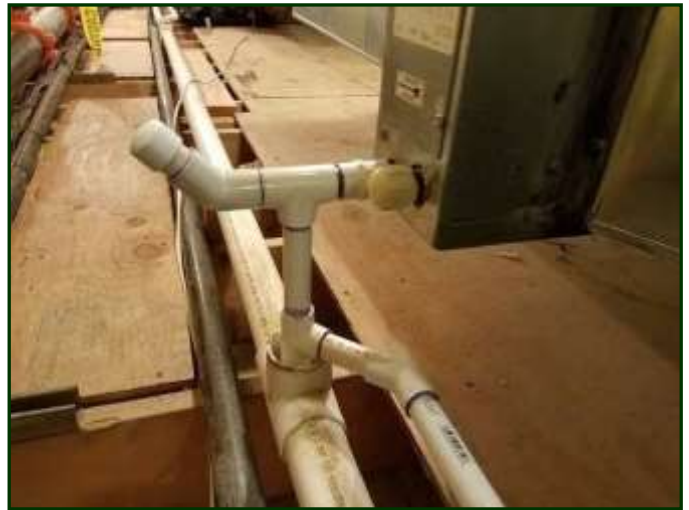
Photo #93: No condensate trap at AHU and open hub drain in attic area

ITEM						Immediate	Reserves
ITEM No.	PHOTO No.	DESCRIPTION	QTY	UNIT	UNIT COST	YEARS 0-1	YEARS 1-5
MECHANICAL SYSTEMS							
13	93, 94	Revise condensate drainage at air handling units in attic area	4	EA	\$75.00	\$300	
14	90	Replace existing split systems (R22) with new indoor AHU and outdoor condensing unit	22	Ton AC	\$1,191.30		\$26,209
15	99	Replace gas-fired hot water boiler system	198	MBH	\$48.74		\$9,651
16	98	Budget for replacement of hot-water baseboard radiators and associated valves	100	LF	\$82.31		\$8,231
17	95, 99, 106	Engage mechanical engineer to investigate and recommend appropriate repair options relating to ventilation requirments	1	LS	\$5,000.00	\$5,000	
18	108	Install dryer exhaust duct to exterior of building	1	LS	\$541.50	\$542	
ELECTRICAL SYSTEMS							
19	109 thru 114	Engage qualified electrician for minor repairs, secure wiring and relocation of electrical panels away from water sources	1	LS	\$4,000.00	\$4,000

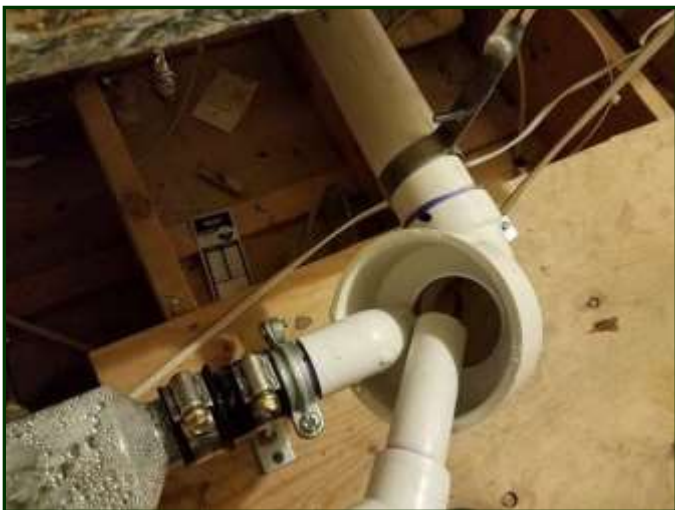
Photo #94: Open hub drain in attic area

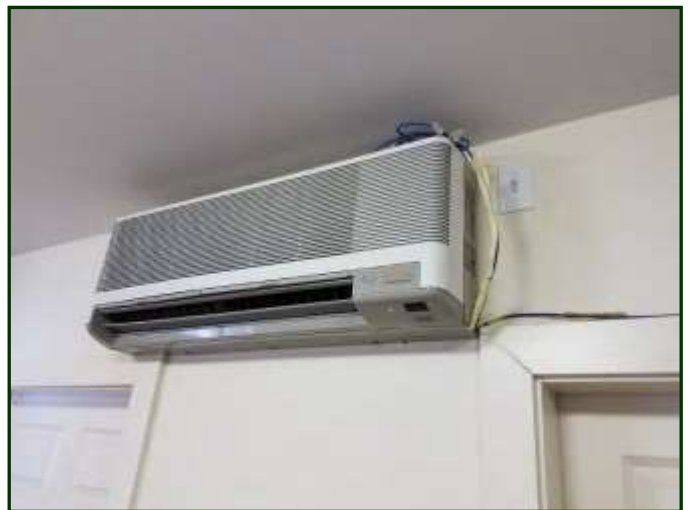
Photo #95: Typical ductless split system

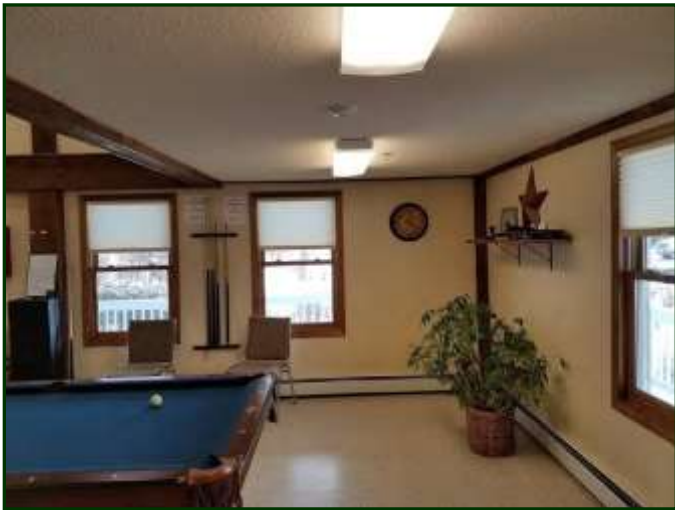
Photo #98: Baseboard hot water radiators in original building

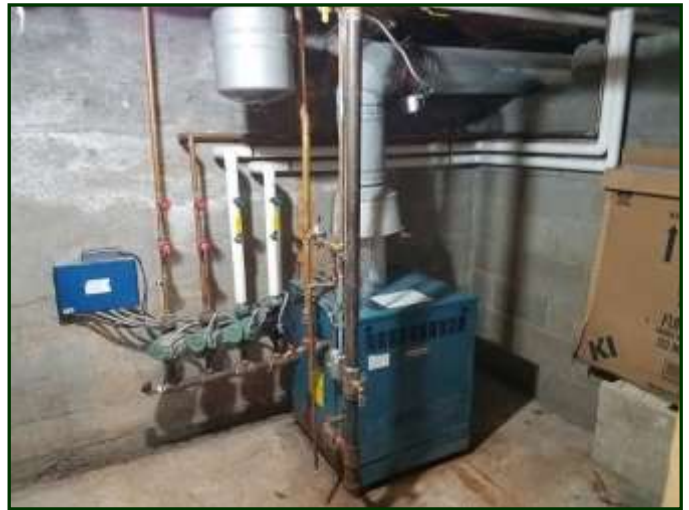
Photo #99: Hot water boiler in basement, no combustion air

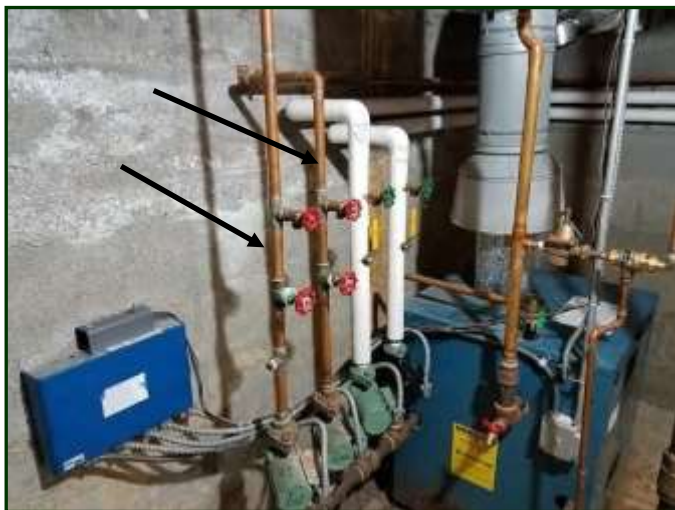
Photo #100: Missing insulation on hot water piping

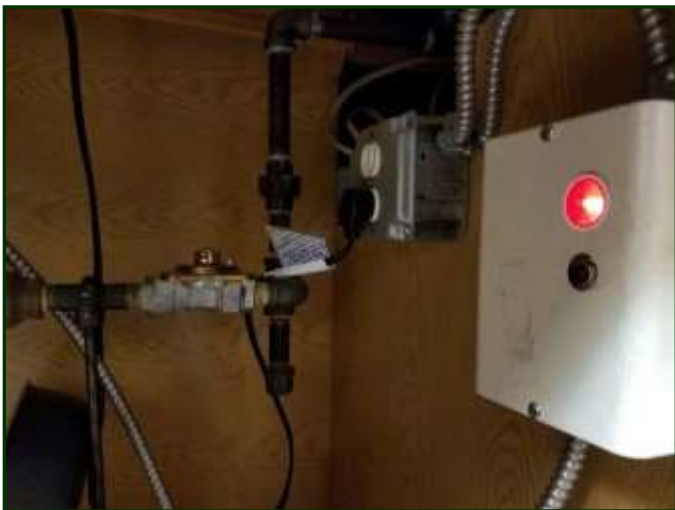
Photo #104: Gas shutoff in cabinet below kitchen range

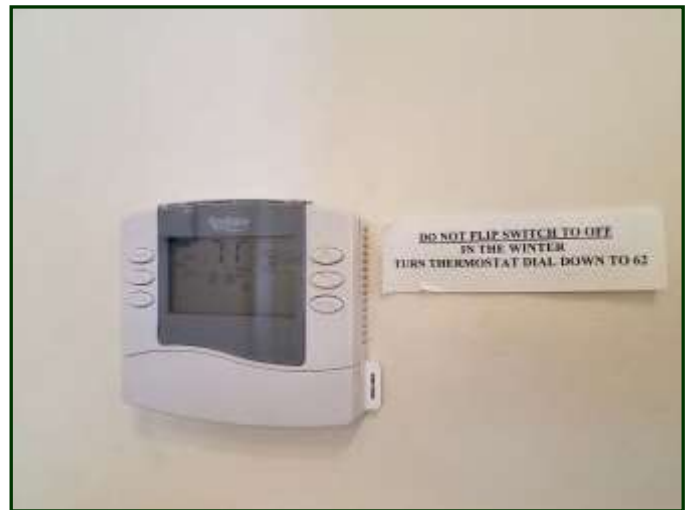
Photo #105: Wall mounted thermostat

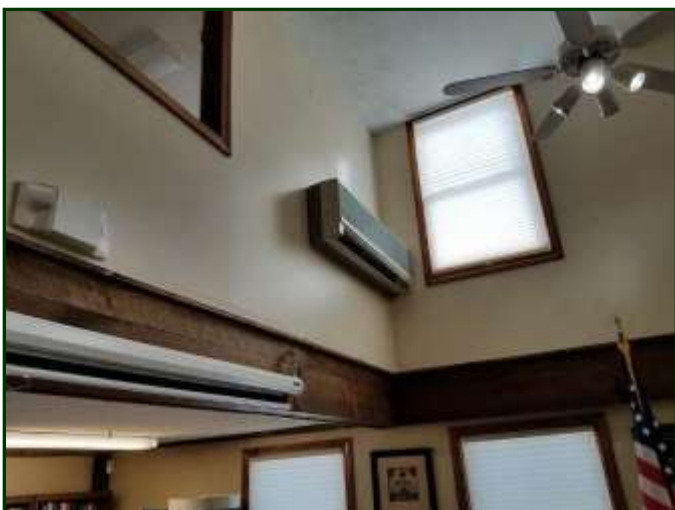
Photo #106: Ductless split system in original building

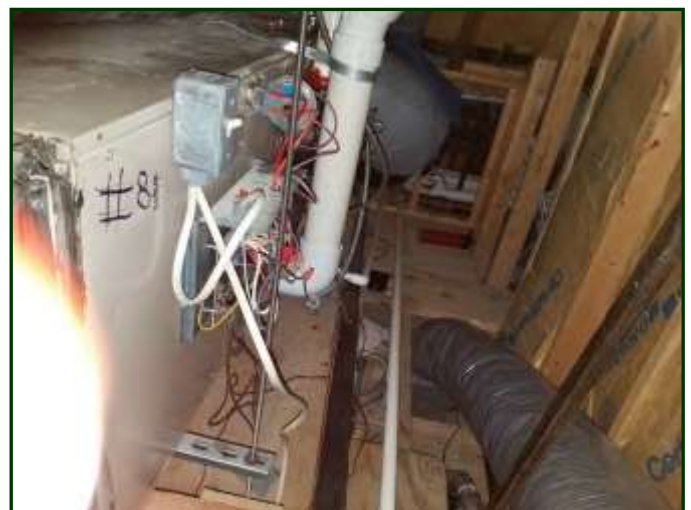
Photo #107: 2nd floor AHU (CES), panel cover not installed

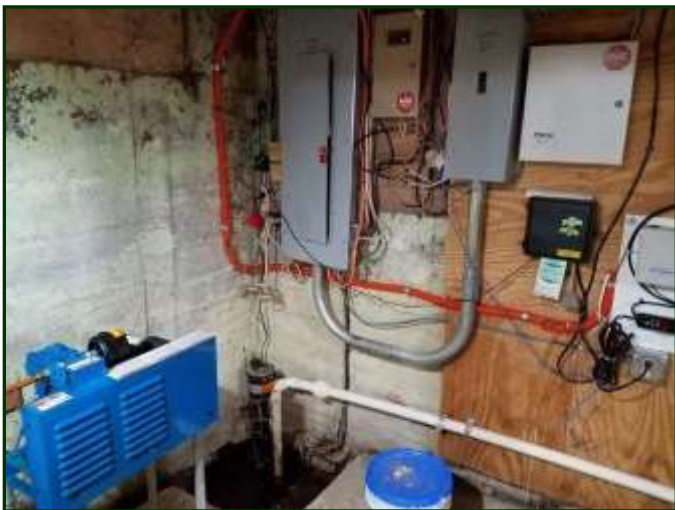
Photo #110: Sump pump area located directly below electrical panel

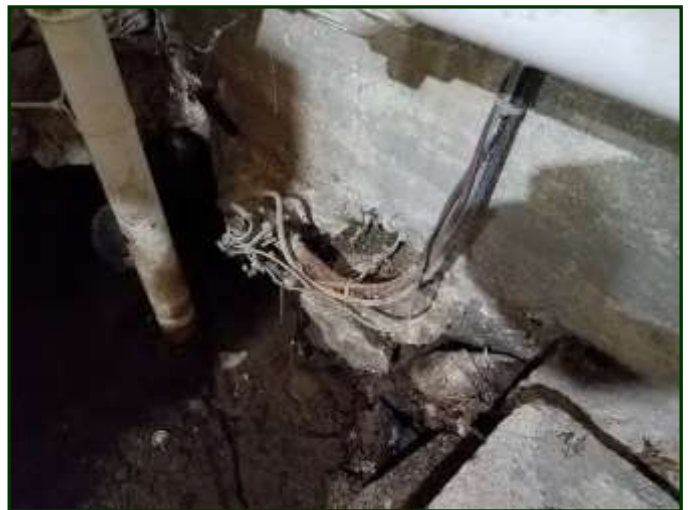
Photo #111: Grounding rod located directly over sump pump area

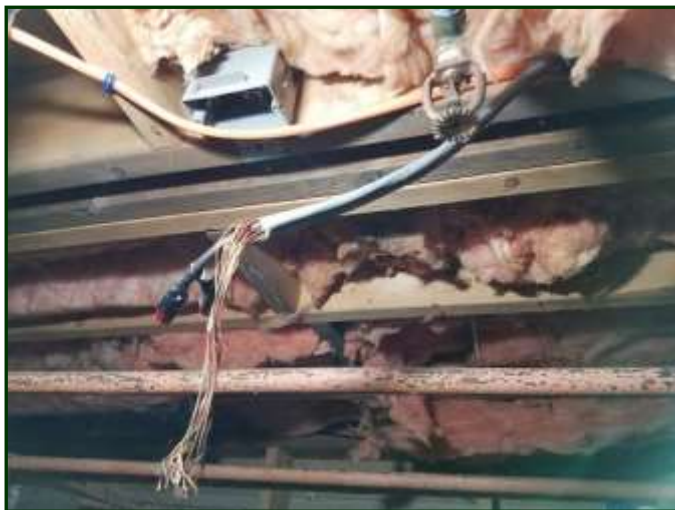
Photo #112: Exposed wiring in basement

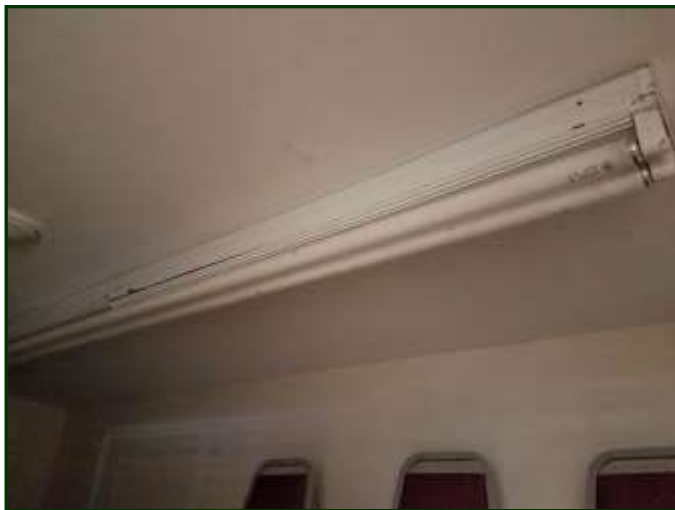
Photo #116: T12 bulbs in most utility areas

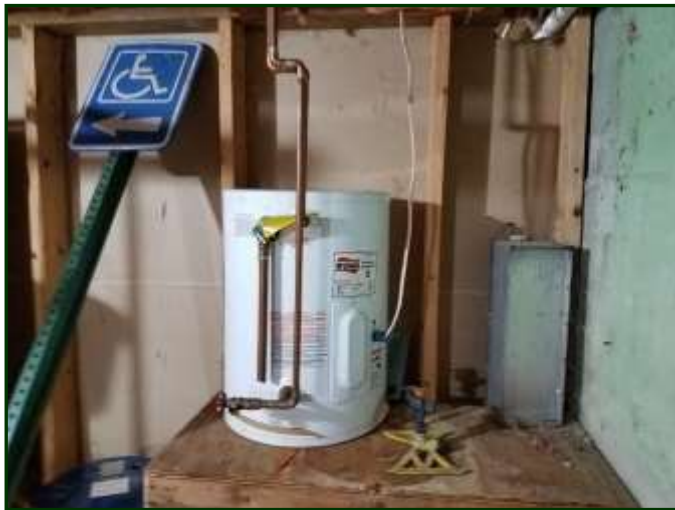
Photo #124: Water heater, basement, located on wood shelf

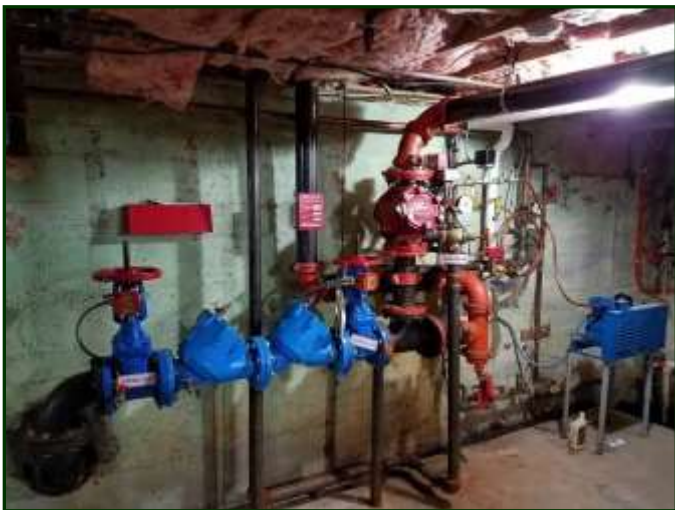
Photo #128: Fire sprinkler system in basement

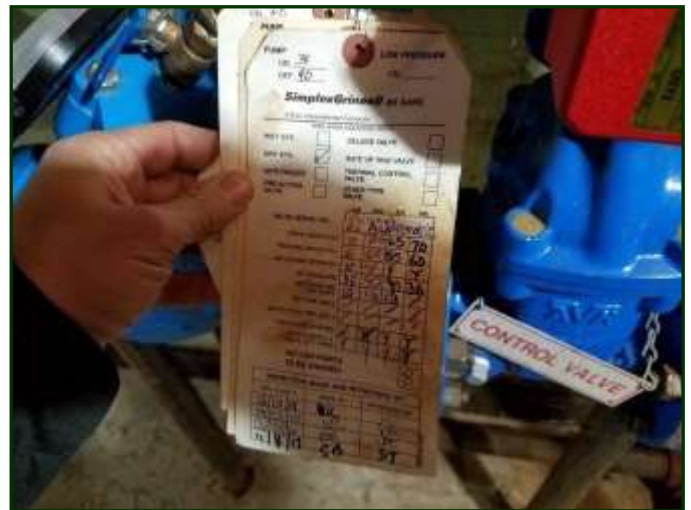
Photo #129: Fire sprinkler inspection tag

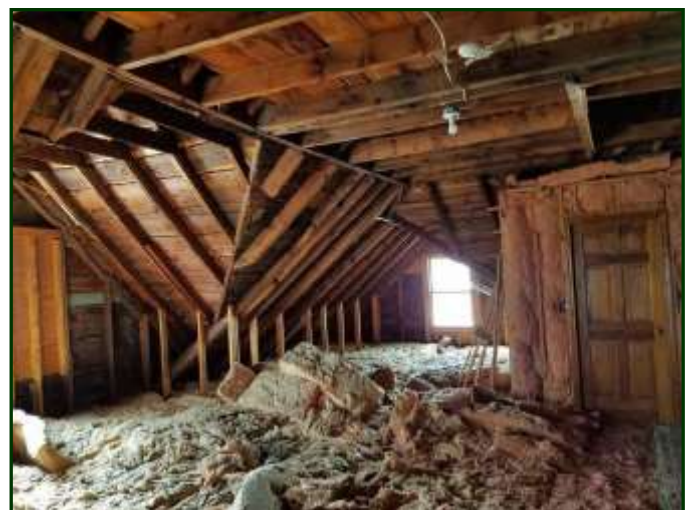
Photo #131: Attic above 2nd floor level, no fire sprinklers in this area

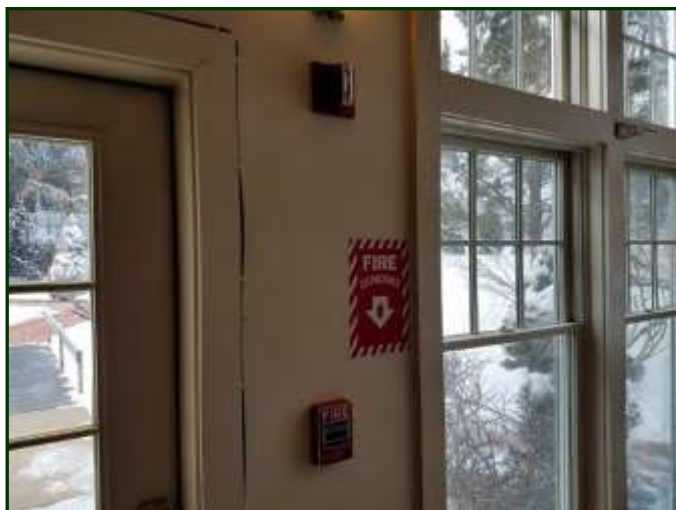
Photo #134: Fire alarm device and strobe on wall

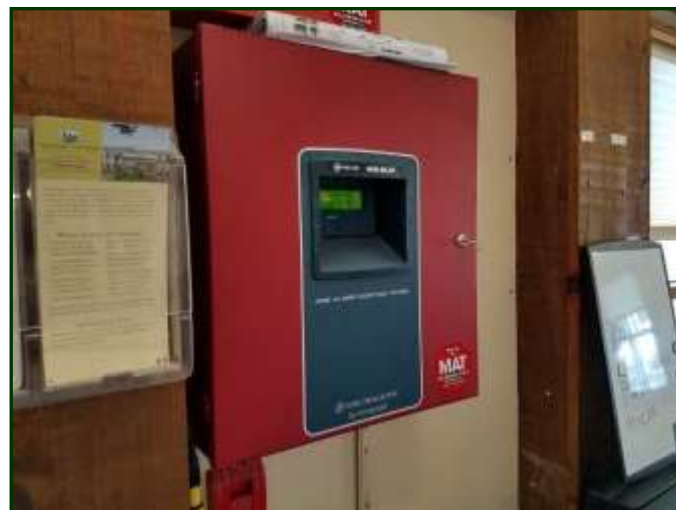
Photo #135: Fire alarm system, no inspection tags observed

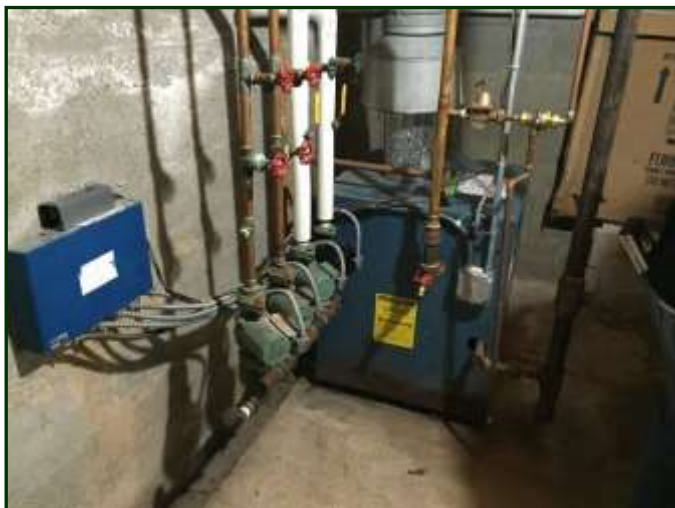
Photo #148: Photograph depicts general view of Gas Fired Boiler in Basement of the Original Section.

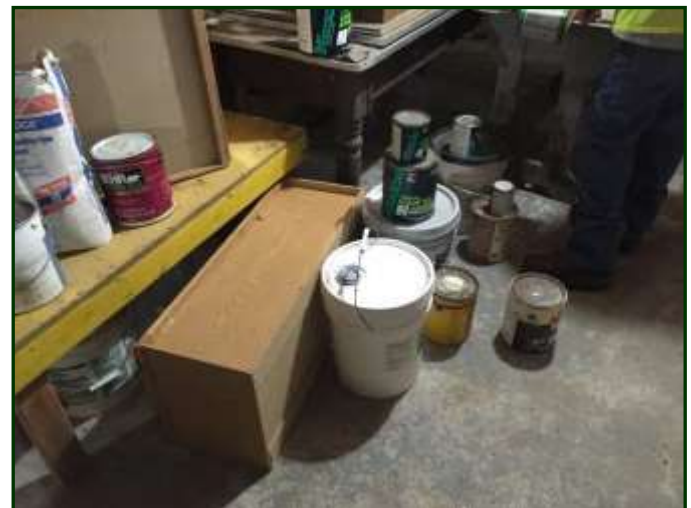
Photo #149: Photograph depicts general view of Paint and Adhesive Storage within Basement of the Original Section .

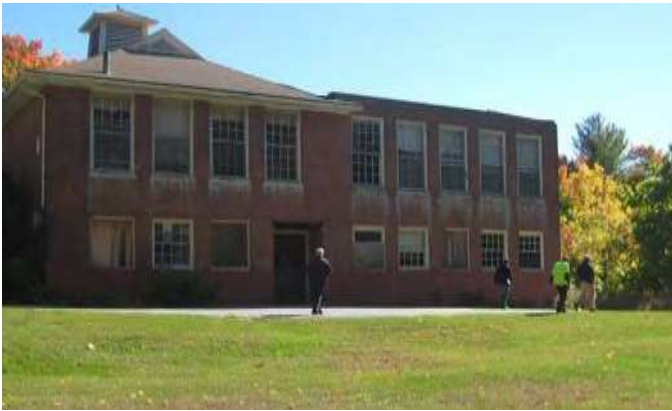
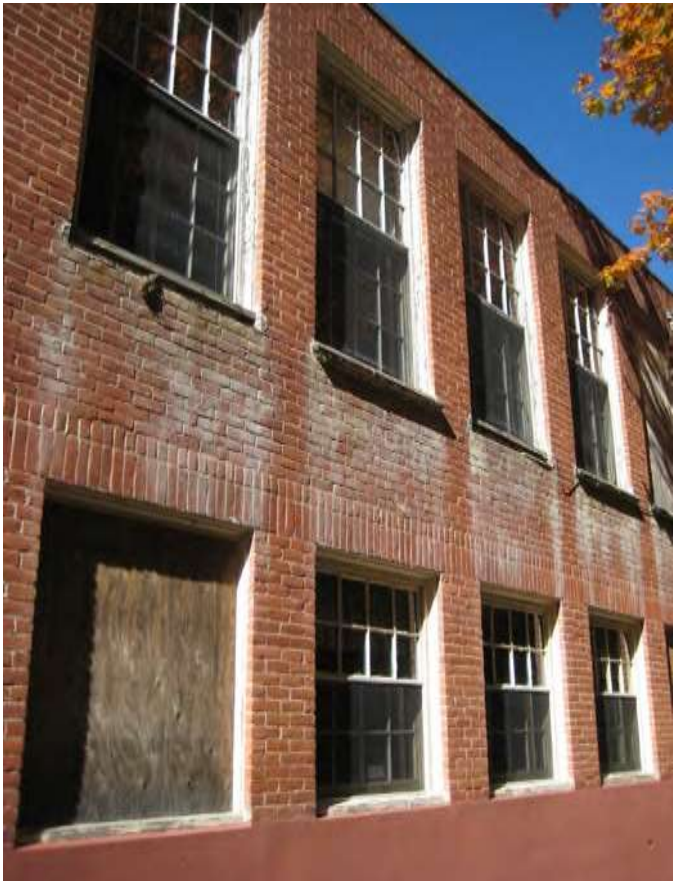
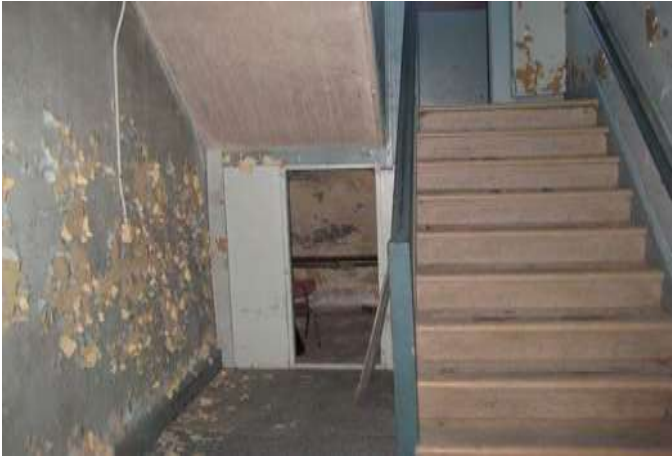
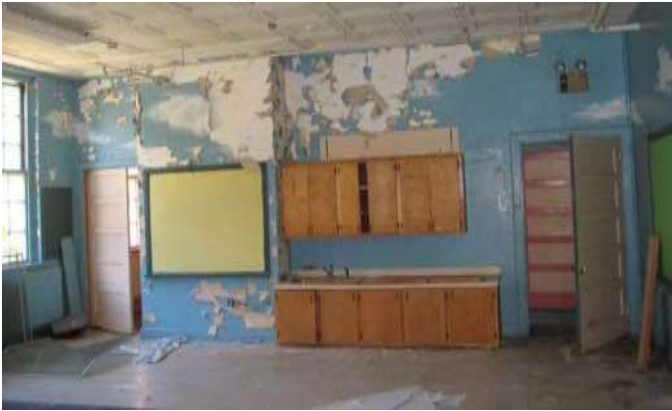
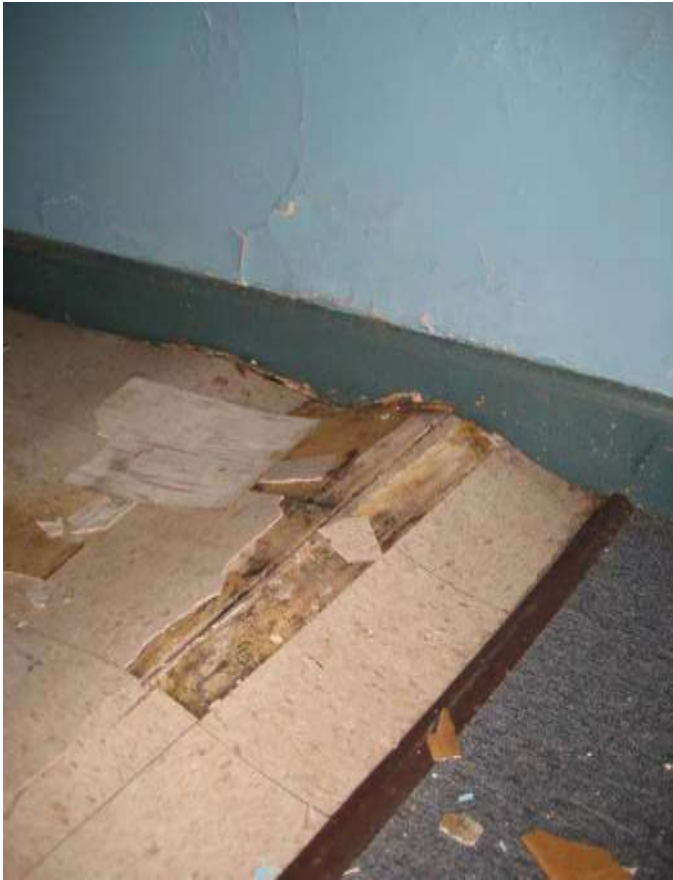
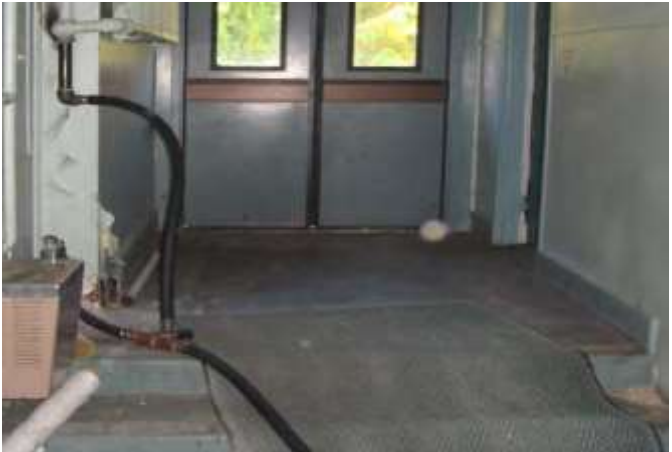
EXISTING CONDITIONS- PRIMARY SCHOOL & RITTER BUILDING

The building has not been in active use for ten years and this condition has led to a general deterioration of the building. The structure is a combination of masonry exterior and bearing walls, concrete slabs and steel roof trusses. The exterior envelope is in need of repairs including lintel replacement, window and roof replacement and masonry restoration in various locations. Removal of interior walls would need to be carefully analyzed relative to structural integrity of the building.

Water has been entering the building resulting in interior slabs that have cracked and heaved. Interior finishes are

generally damaged and in need of repair and all building systems require replacement. The building has multiple interior floor elevations and grade is at a mid-level, making the building generally non-accessible.

The Ritter Building was constructed in 1910 with an addition in 1963 and served as the Town Library for many years. The overall area is approximately 6,000 SF on two levels. The building is in generally good condition with limited upgrades required. There is currently no sprinkler system or air conditioning.

The building structure is wood with exterior masonry bearing walls. Interior finishes are generally in good condition and the building has been generally well maintained. The current condition is not fully accessible and any anticipated renovation and re-use would need to make modifications to accommodate a main building entrance and bathrooms that is accessible, as well as accommodating the public on both floors of the building.
